**Manual Updates for  
A Couple of Mazda Valve Bodies**

**TRANSMISSION DIGEST CORRECTION  
January 2004 Issue  
Page 12**

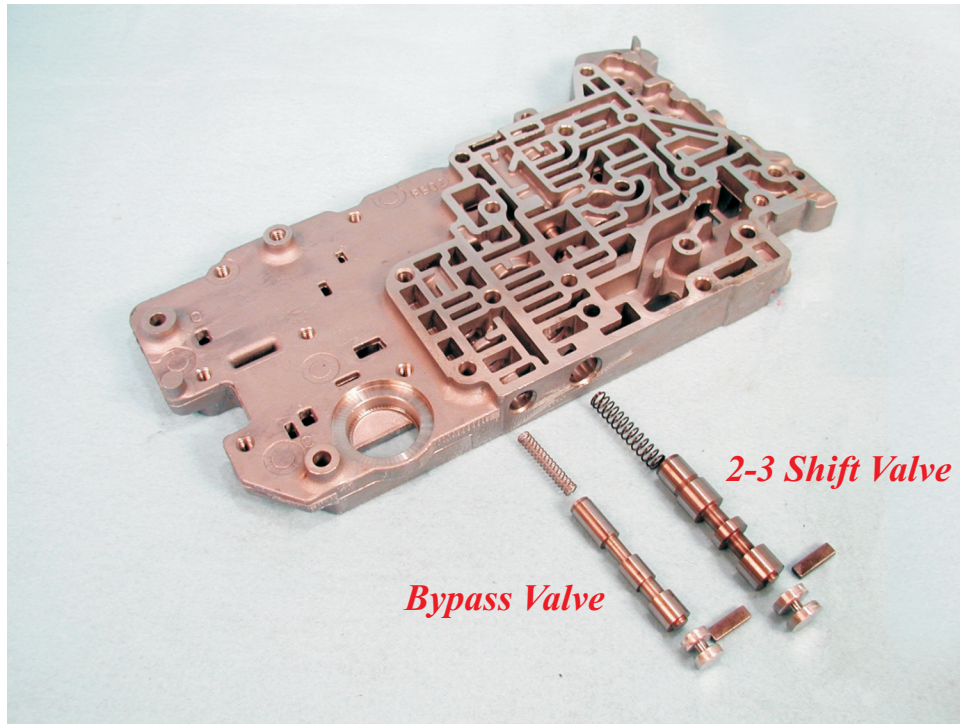
Figure 4

Another manual update that would be good to make is with the F4EAT transaxle. The 2-3 Shift Valve and the Bypass Valve are side by side near the inlet port of the valve body as seen in Figure 4. These valves have been oppositely labeled. This error can lead to a no 2-3 up shift problem after overhaul. The reason for this is that many technicians peg the bypass valve to allow for a firmer 2-3 shift. This works with the G4A-EL, the GF4A-EL and the F4EAT transaxles alike. If a technician is unaware of the mislabeling of the valves in F4EAT valve body information, the 2-3 shift valve is unknowingly pegged preventing the 2-3 shift to take place. One way to remember the correct valve is that the Bypass Valve is closest to the inlet and that the 2-3 Shift Valve is the larger of the two.
